THE DQ SWITCH

Operation at 4 Million Volts and 800 Kiloamperes

John W. Douglas
Walter F. J. Crewson
Carleton H. Jones, Jr.
Pulsar Associates, Inc.
11491 Sorrento Valley Road
San Diego, California 92121

Final Report for Period 1 April 1979—1 December 1979

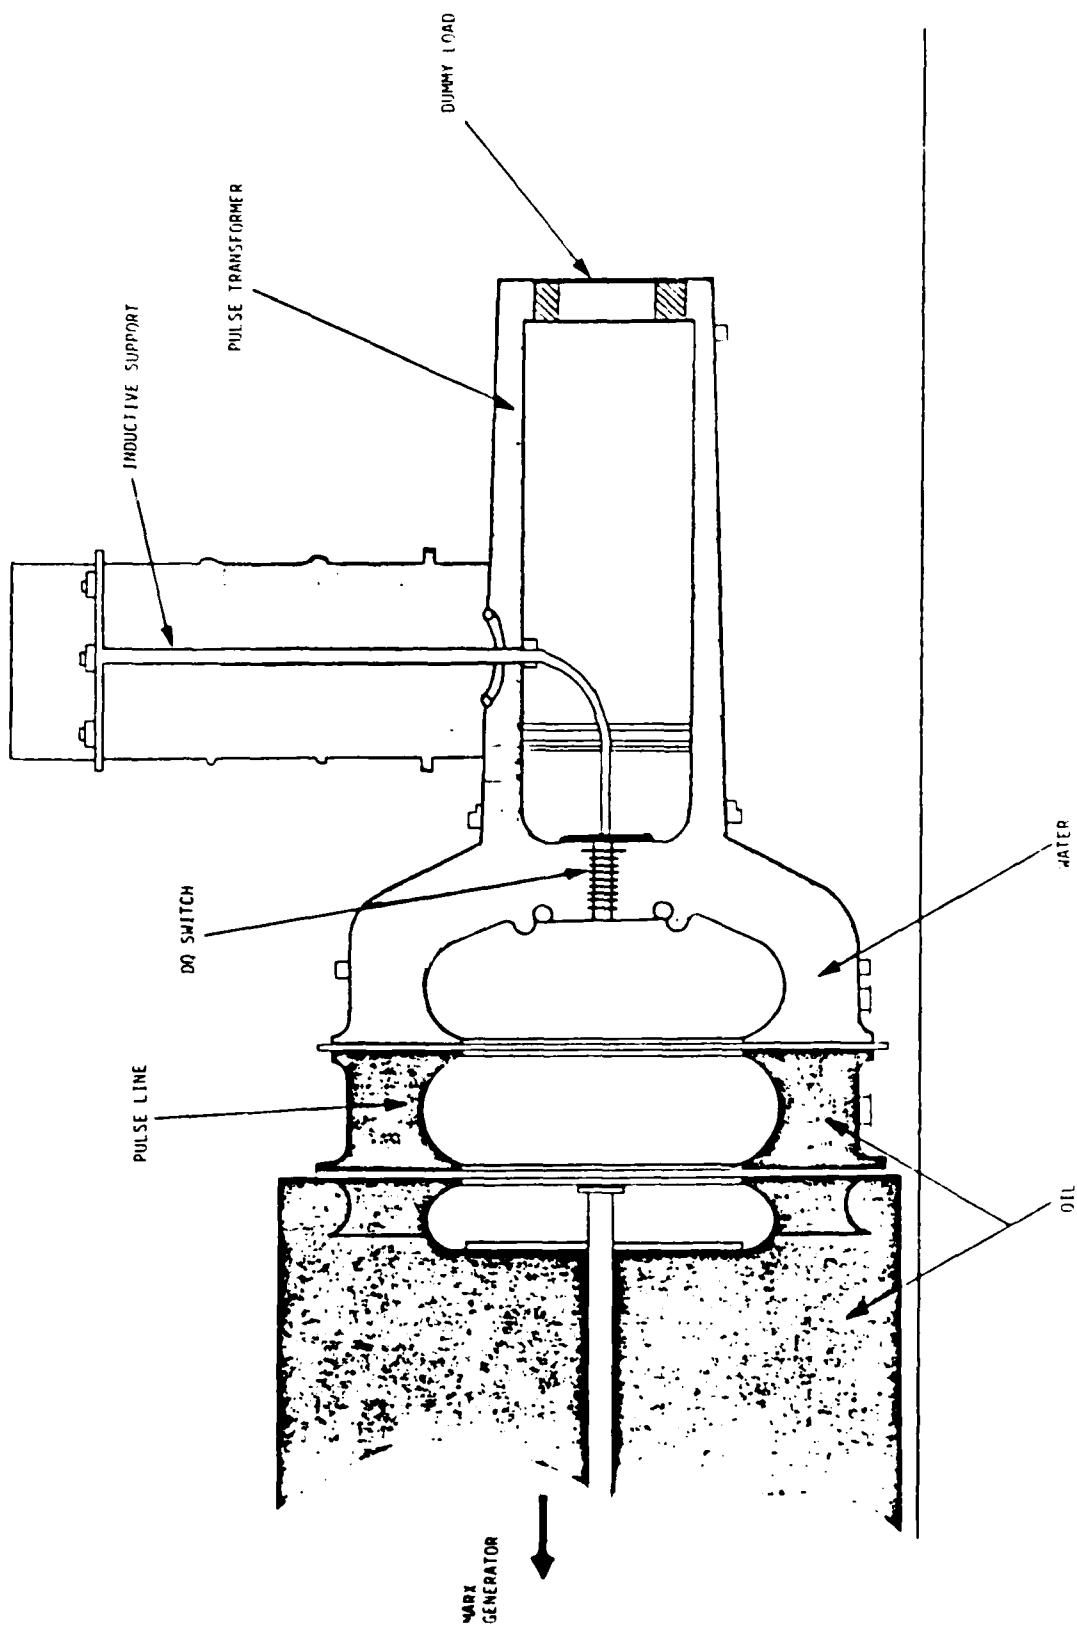
FIGURE 1 CASINO DQ TEST CONFIGURATION

The test configuration at Casino for the DQ switch is shown in Figure 1. The switch closes the gap between the pulse line and the pulse transformer. The trigger cable for the switch enters the system through the inductive support at the load side of the switch. In a typical test shot, the pulseline is charged to approximately four megavolts. When the switch fires, the output pulse is about 80 nS wide with a peak current of 800 kA. Figure 2 is an outline view of the DQ switch in the pulseline. The active length of the switch is 20.5 inches, including 18.8 inches of wall insulation. The "blow down" tank is a gas ballast volume which helps to flush the switch when pressure is dropped after each firing. Details of the interior of the switch can be seen in Figures 3 and 4, which show the trigger section, and Figure 5, which shows the middle sections of the switch. The full switch is shown in Figure 5.1.

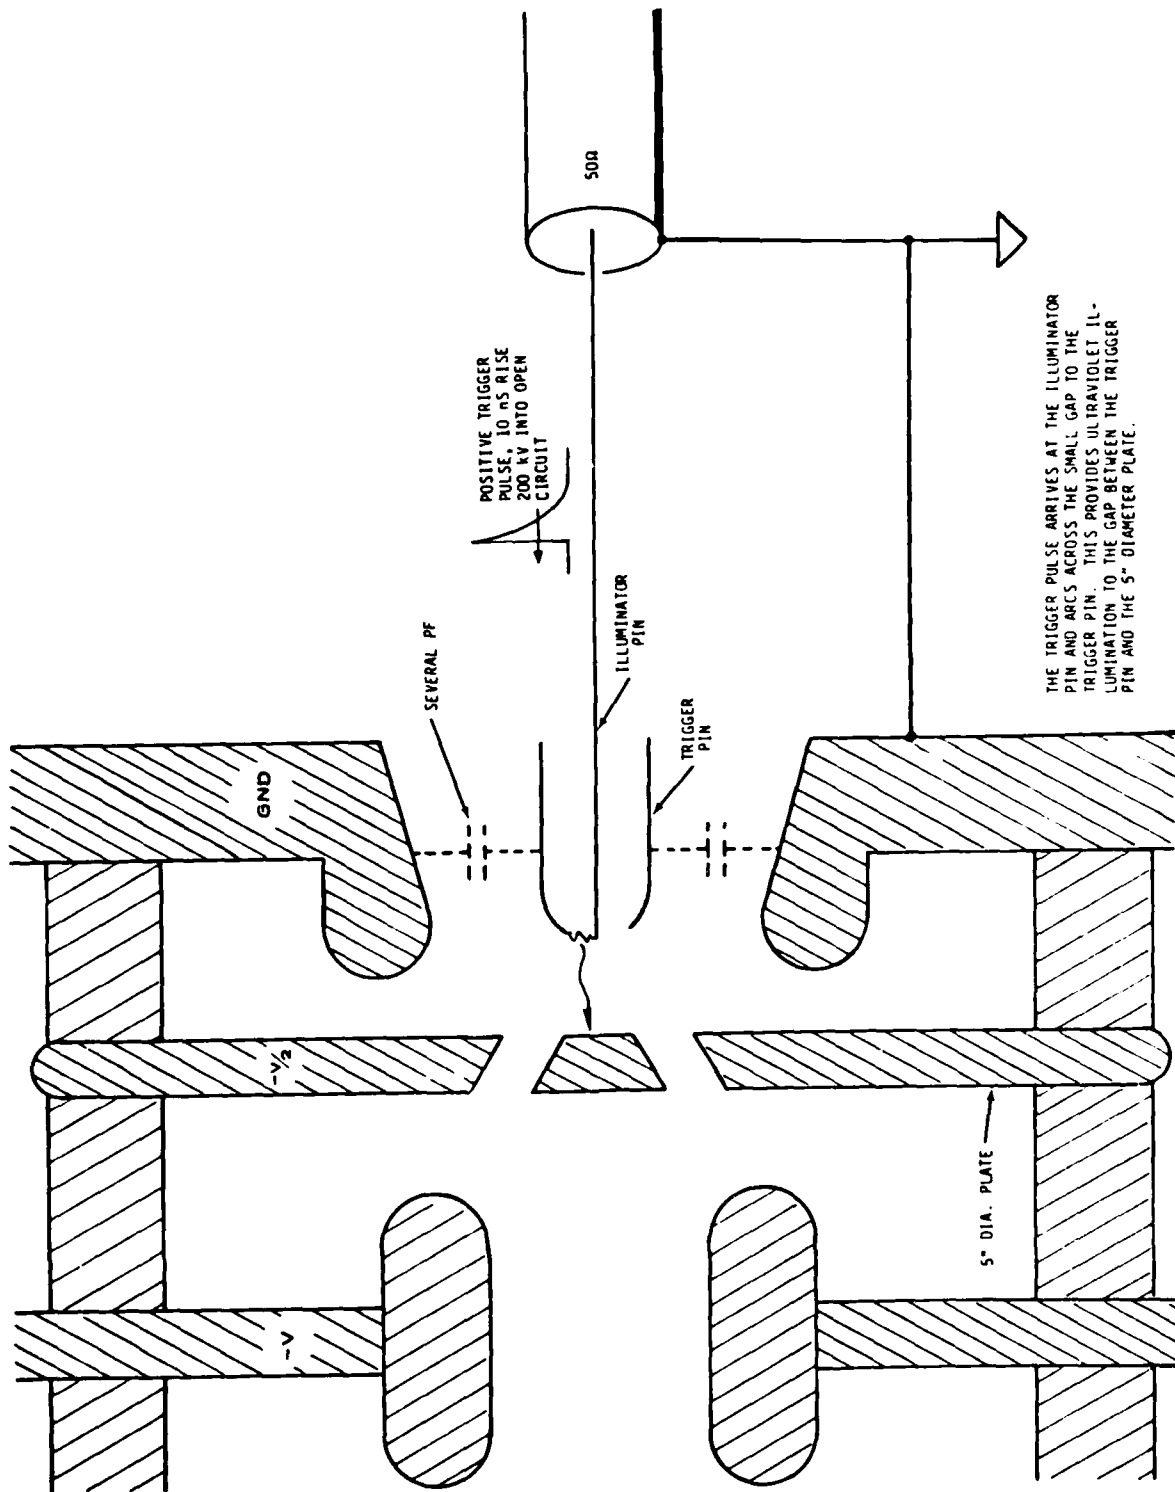
FIGURE 6 TRIGGER SECTION OPERATION

The trigger section of the DQ switch was developed at Pulsar under an internal R&D program. Its design has been carefully arranged so that at each stage in the breakdown of this key section, there is always adequate ultraviolet on the cathode of the subsection next to be overvolted. The operation of the trigger section is shown in Figures 6 through 9.

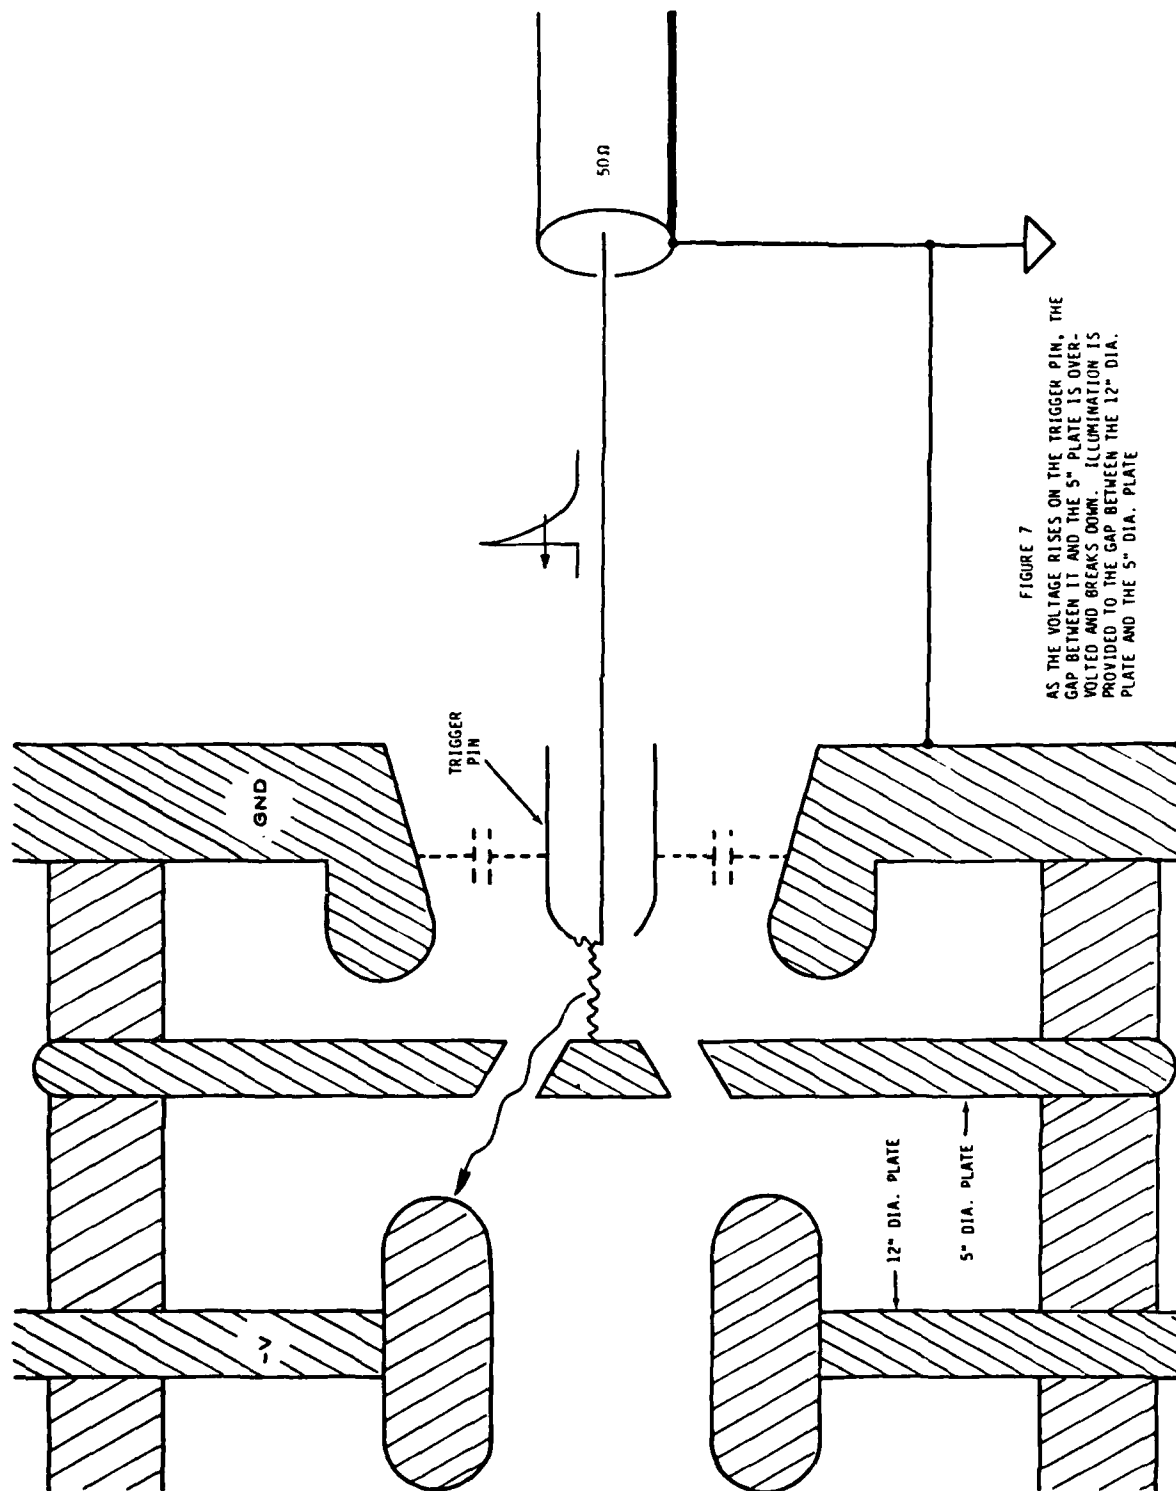
FIGURE 7 TRIGGER SECTION OPERATION

FIGURE 7
AS THE VOLTAGE RISES ON THE TRIGGER PIN, THE
GAP BETWEEN IT AND THE 5" PLATE IS OVER-
VOLTED AND BREAKS DOWN. ILLUMINATION IS
PROVIDED TO THE GAP BETWEEN THE 12" DIA.
PLATE AND THE 5" DIA. PLATE

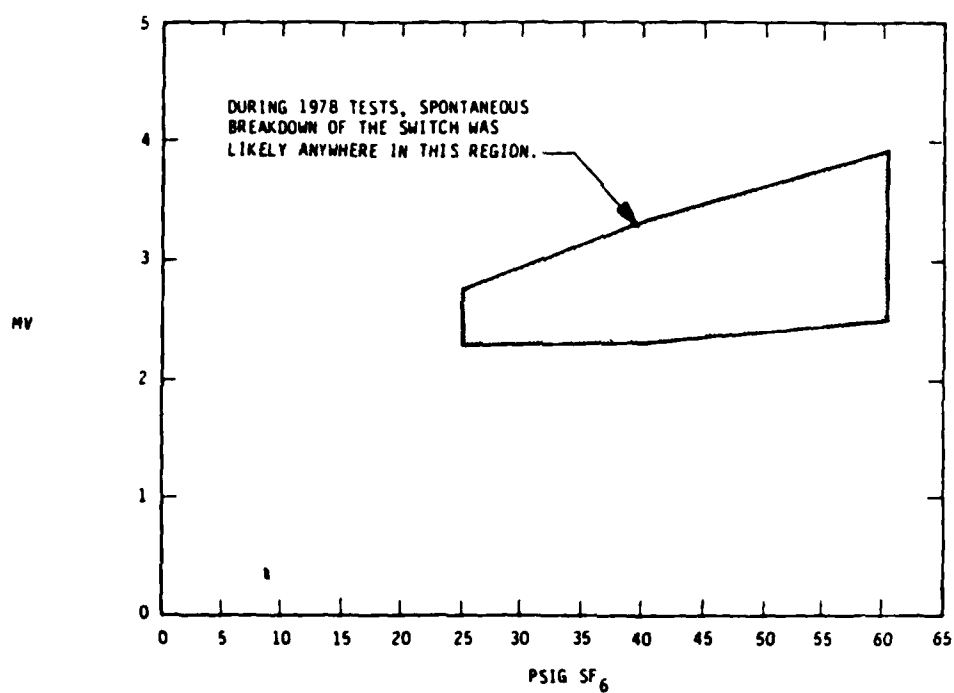
FIGURE 10 DQ SWITCH SELF-BREAK MODE OPERATING RANGE JULY 1978

The 1978 tests of the DQ switch showed that further progress would first require the elimination of the spurious breakdown of the switch above two million volts. The self-breakdown voltage varied so much from shot to shot that it was very difficult to reliably obtain a shot above two megavolts. This situation made testing of triggered operation virtually impossible because of the wide and uncertain timing intervals required. The 1978 region of breakdown using SF₆ is shown in Figure 10.

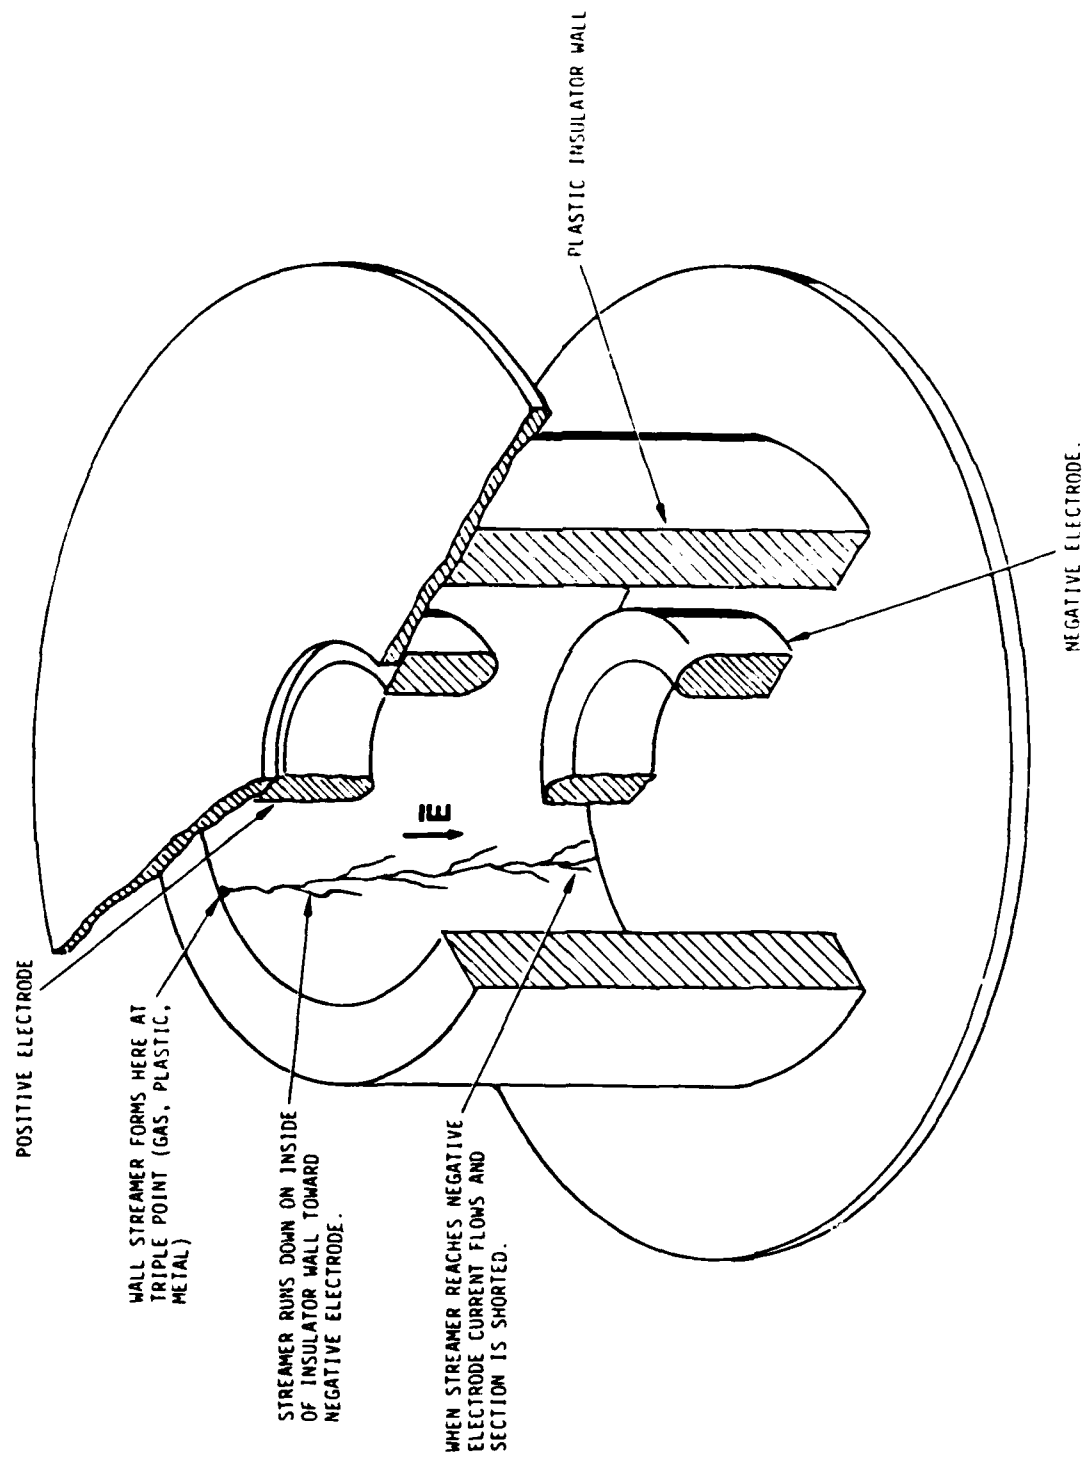
FIGURE 10.1
WALL STREAMER FORMATION INSIDE OF SWITCH SECTION

The spurious breakdowns were attributed to electrical streamers or insulator wall tracks upsetting the electrical grading of the switch, and thereby firing it. The general description of the insulator streamer is shown in Figure 10.1. It is important to note that these streamers usually left little or no trace, and very rarely damaged the insulator. Their effect was believed to be confined to upsetting the electric field gradients, causing the switch to fire.

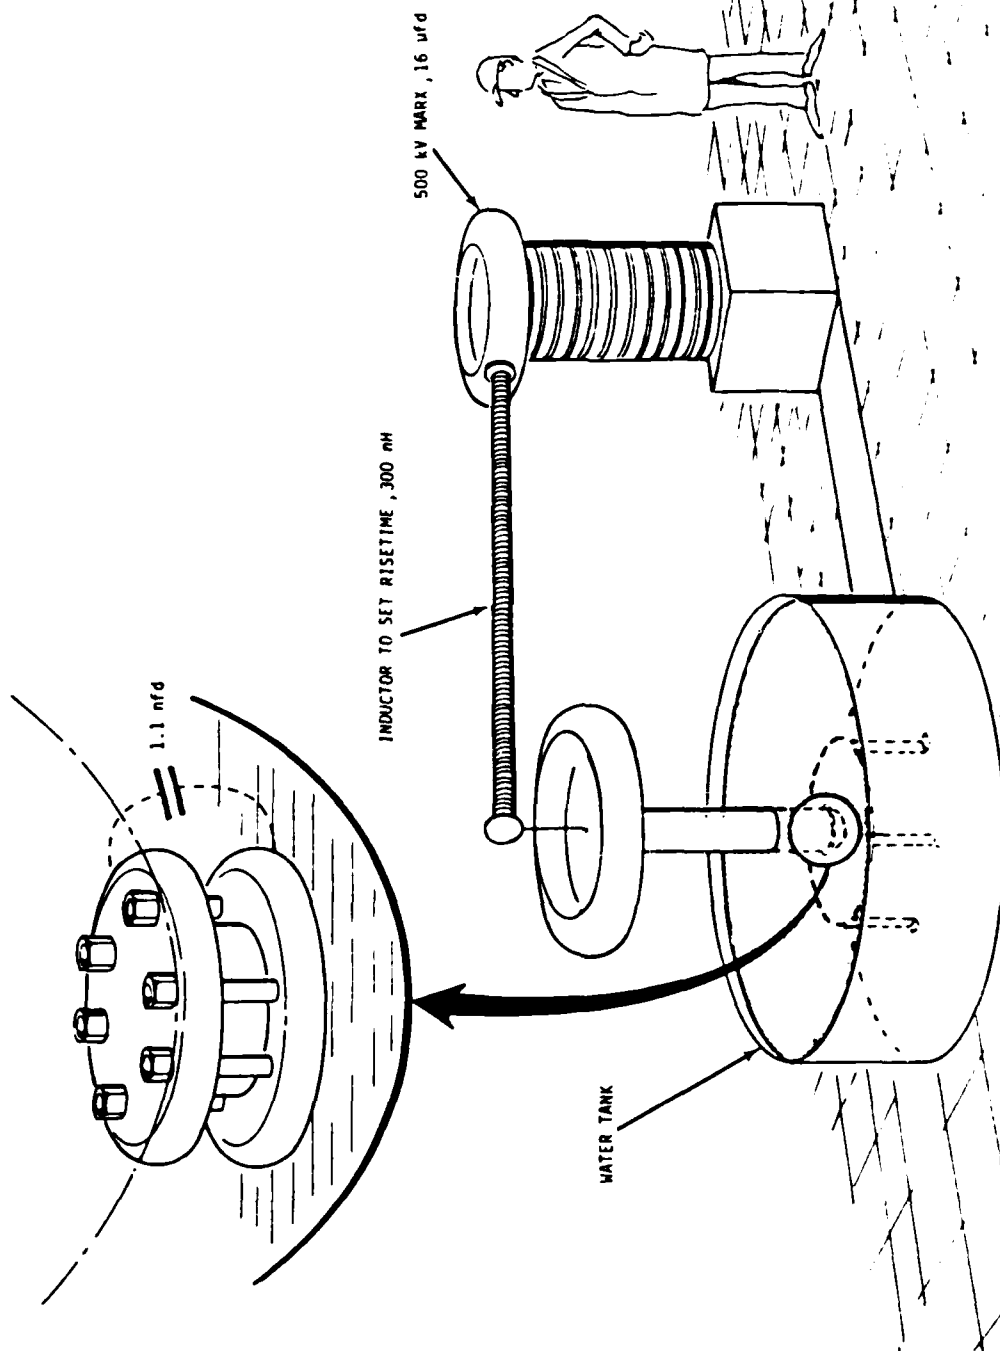
FIGURE 11
DO SWITCH TEST STAND

The set-up used for testing the insulator sections is shown in Figure 11. Figure 12 is a block diagram of the diagnostics. The test stand had a peak output of 450 kV with a 1.5 microsecond risetime. For the single-section tests, 1977-type switch insulator sections were used. These sections were only half the size of the present DQ insulators, so they represented a 50 percent scale model. The outside insulator diameter was 2.4 inches, instead of the five inches of the large version used at Casino. The length for the small insulators was one inch, compared to the larger type's two inches. At a typical peak operating voltage of 300 kV, a waveform of approximately 60 kA peak current oscillated in the DQ switch section immediately after breakdown.

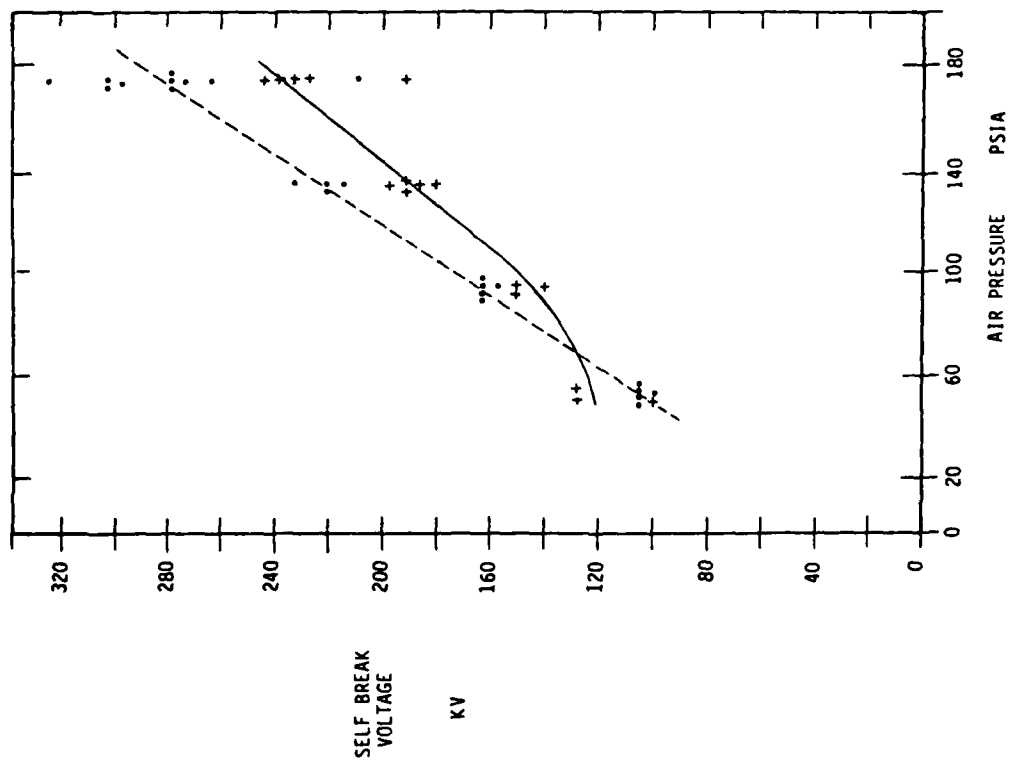
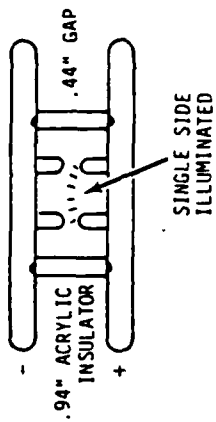
FIGURE 13 6/26/79 TESTS

NOTE: NO WALL TRACKS SEEN ON INSIDE OF INSULATOR.

• ILLUMINATED BOTH SIDES
+ NON-ILLUMINATED

However, a different test revealed a most striking effect concerning the effects of UV illumination. This concerned the behavior of the self-break curve for straight-walled insulators when UV illumination was removed. Instead of a slight increase in the apparent self-break voltage when UV was removed from the interior of the test switch, as one might expect to result from a small increase in the breakdown time delay, exactly the opposite effect was observed at higher voltages. The crossover point appeared to be at 65 psig and 140 kV. Figures 13 and 14 show typical examples of the effect. Note that although the absolute values of the two illuminated curves vary slightly due to calibration errors, the fractional difference between the illuminated and nonilluminated curves increases at a fairly continuous rate (see Figure 15).

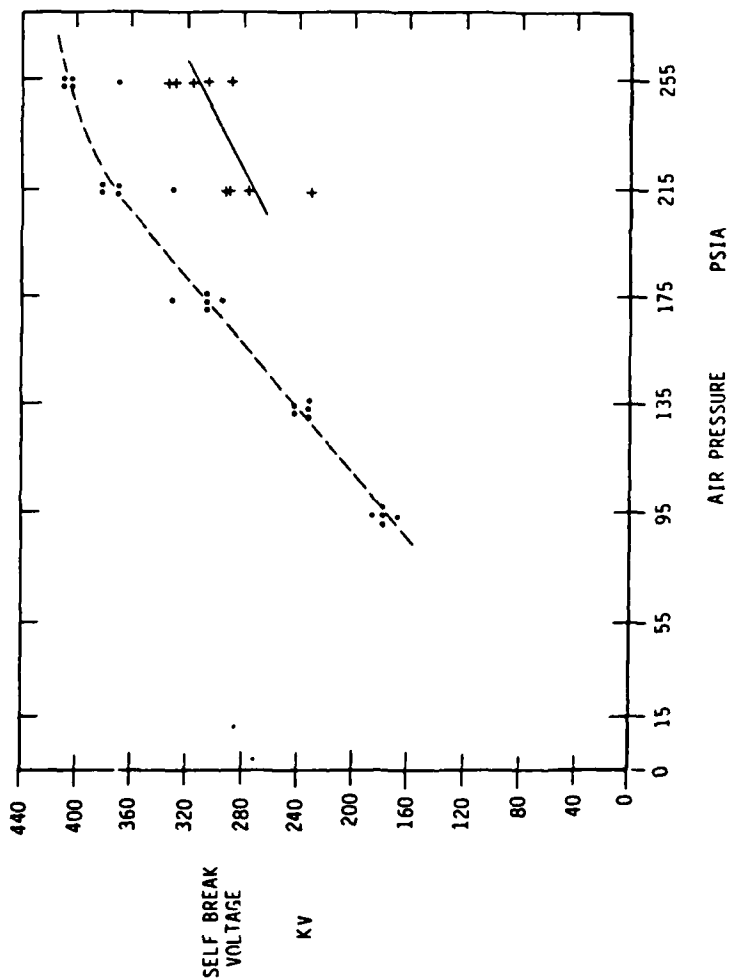
FIGURE 14 6/29/79 TESTS

NOTE: NO WALL TRACKS WERE OBSERVED ON INSIDE OF INSULATOR SURFACE.

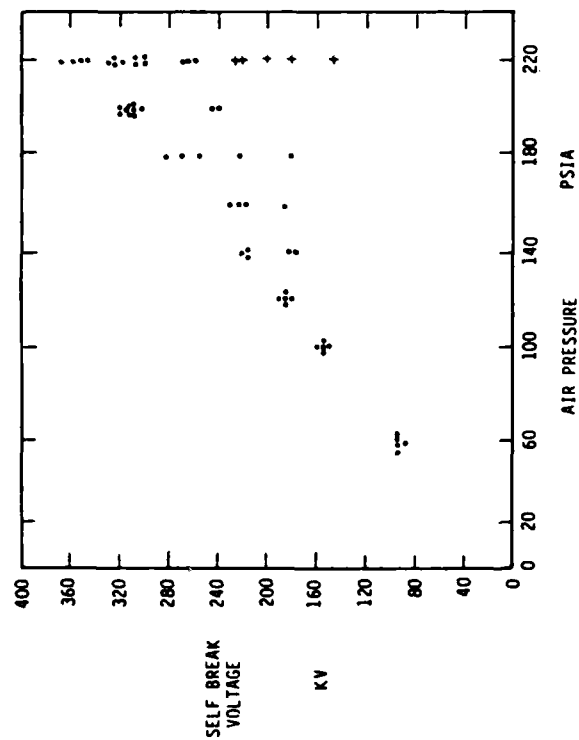
FIGURE 16 7/6/79 TESTS

• ILLUMINATED
+ NON-ILLUMINATED

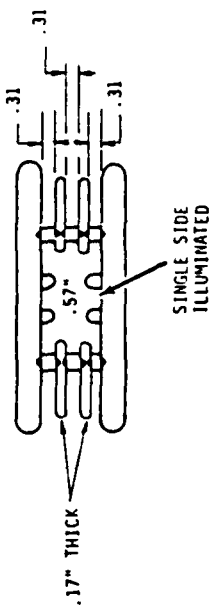
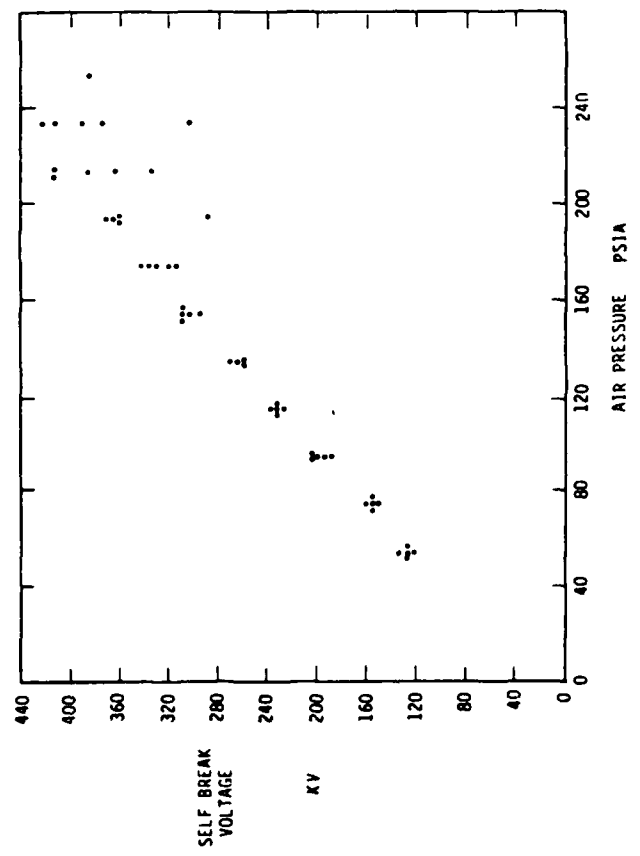
FIGURE 17 7/3/79 TESTS

NOTE: WALL TRACKS WERE OBSERVED ON INSIDE OF ALL 3 INSULATORS. BURN MARKS WERE SEEN ON GRADING RINGS NEAR INSULATOR.

not illuminated; and, therefore, it was believed likely that the switch was effectively nonilluminated. Wall tracks were seen on each of the three insulators. The poor results, coupled with the increased complexity, caused this approach to be abandoned.

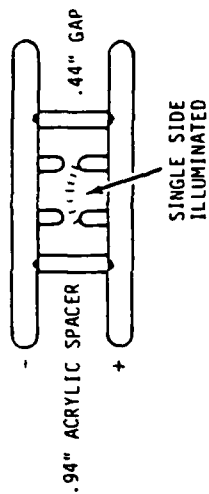
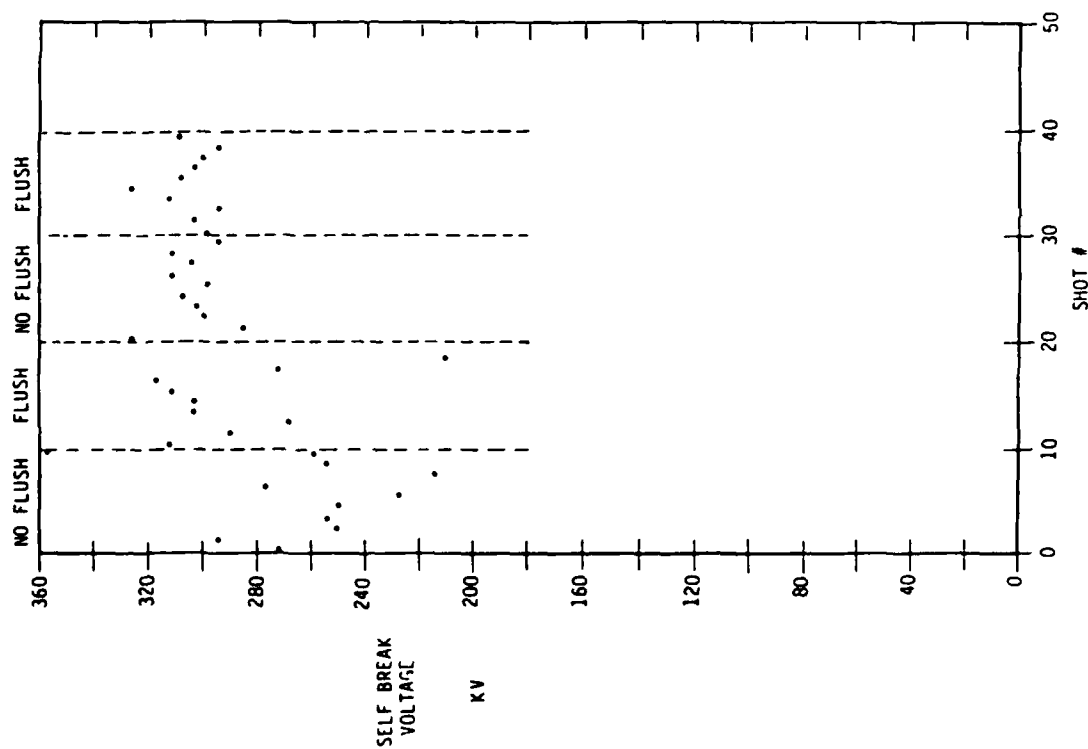
FIGURE 19 6/21/79 TESTS

TEST SEQUENCE OF 6/21/79
 ALTERNATING SEQUENCES OF FLUSH AFTER
 EACH SHOT AND NOT, 10 SHOTS/SEQUENCE.

SWITCH PRESSURE: 185 PSIG

SWITCH GAS: AIR

doing so, the test sequence reported in Figure 19 was conducted. There was apparently no effect, due to gas changes, on the self-break voltage for the number of shots made. The only noticeable effect on the switch was a narrowing of self-break scatter over time. Note that, in all of the other tests discussed here, the switch was flushed with new gas after every shot, unless otherwise indicated.

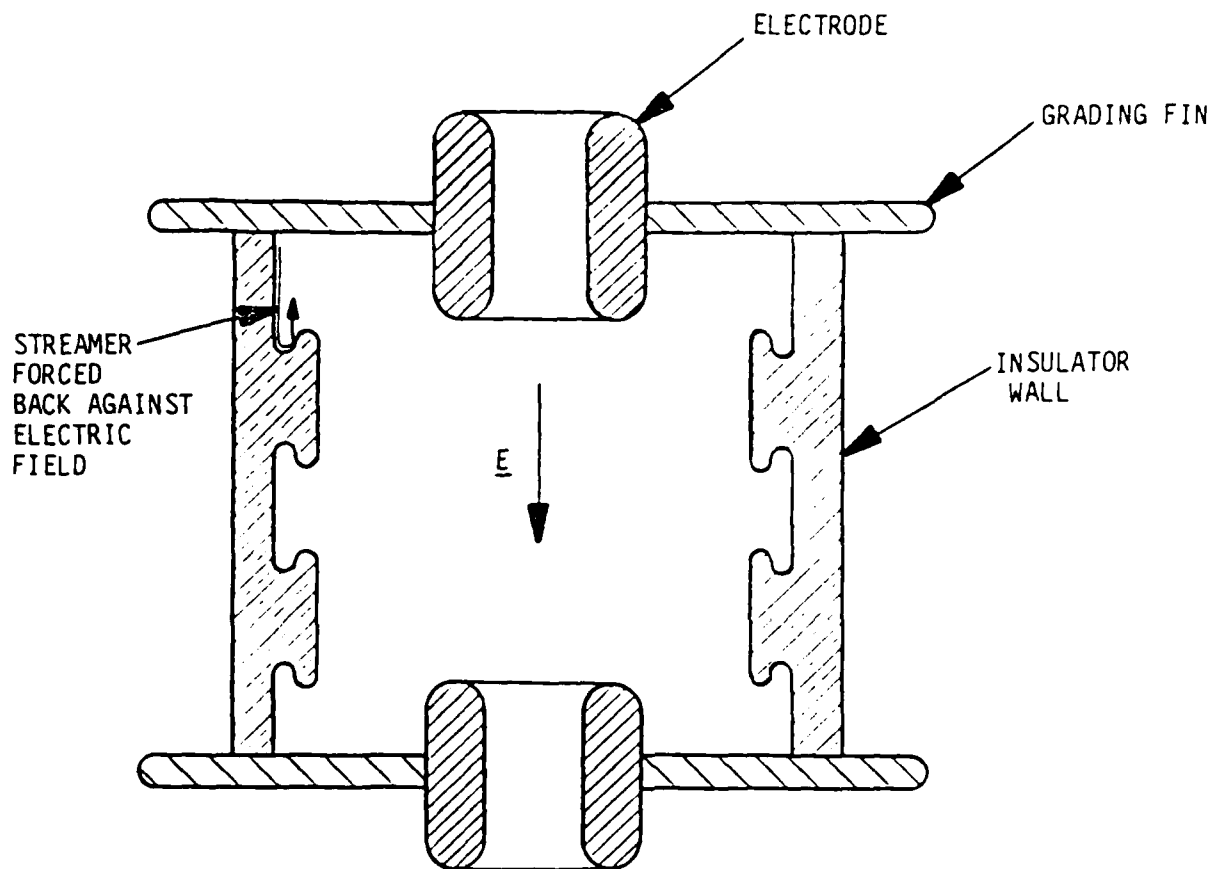
FIGURE 20
CONVOLUTED INTERIOR INSULATOR WALLS
TO CONTROL TRACKING.

THIS APPROACH WAS NOT SUCCESSFUL.

Passive measures had been considered. One approach was to attempt to physically block streamer travel as shown in Figure 20. This approach has been tried by other groups⁴, and was tried with the DQ switch by the Casino staff. Contrary to our earlier expectations, it has always proved to be ineffective. Apparently, the energy of the streamer, once started, is just too great. After a very few shots, the barriers are simply blown off or tunneled through.

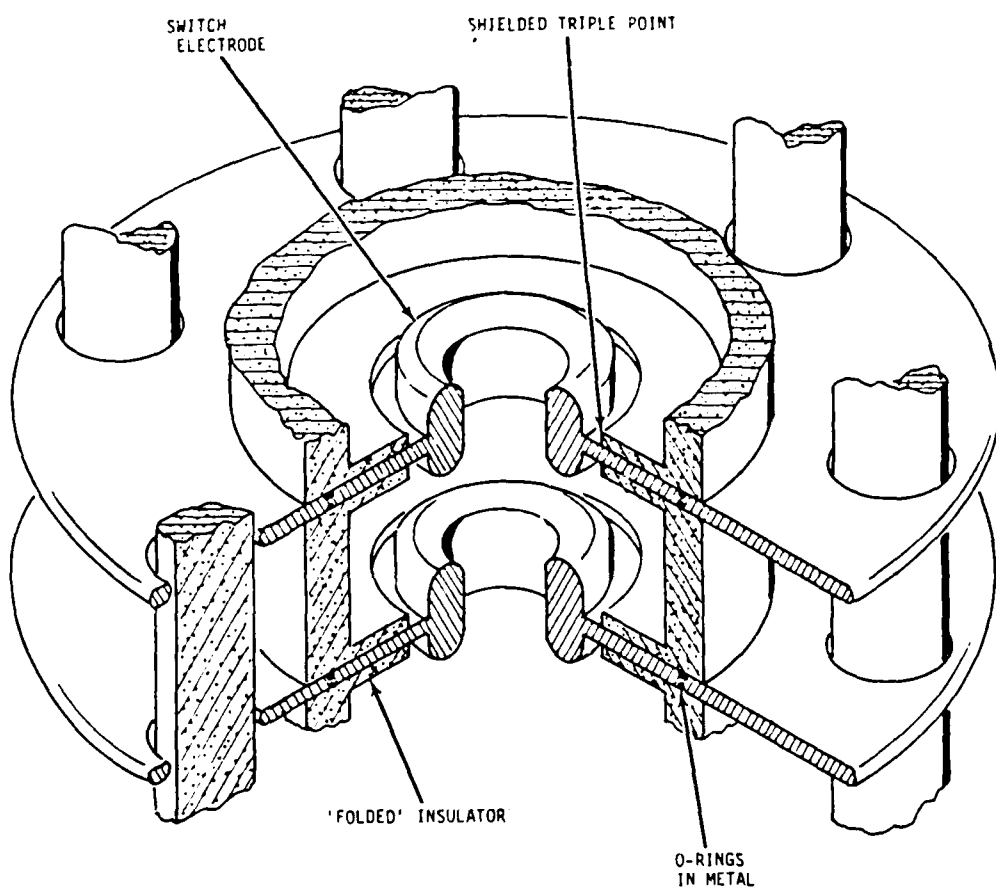
FIGURE 21

DQ SWITCH SECTION
WITH FOLDED INSULATOR

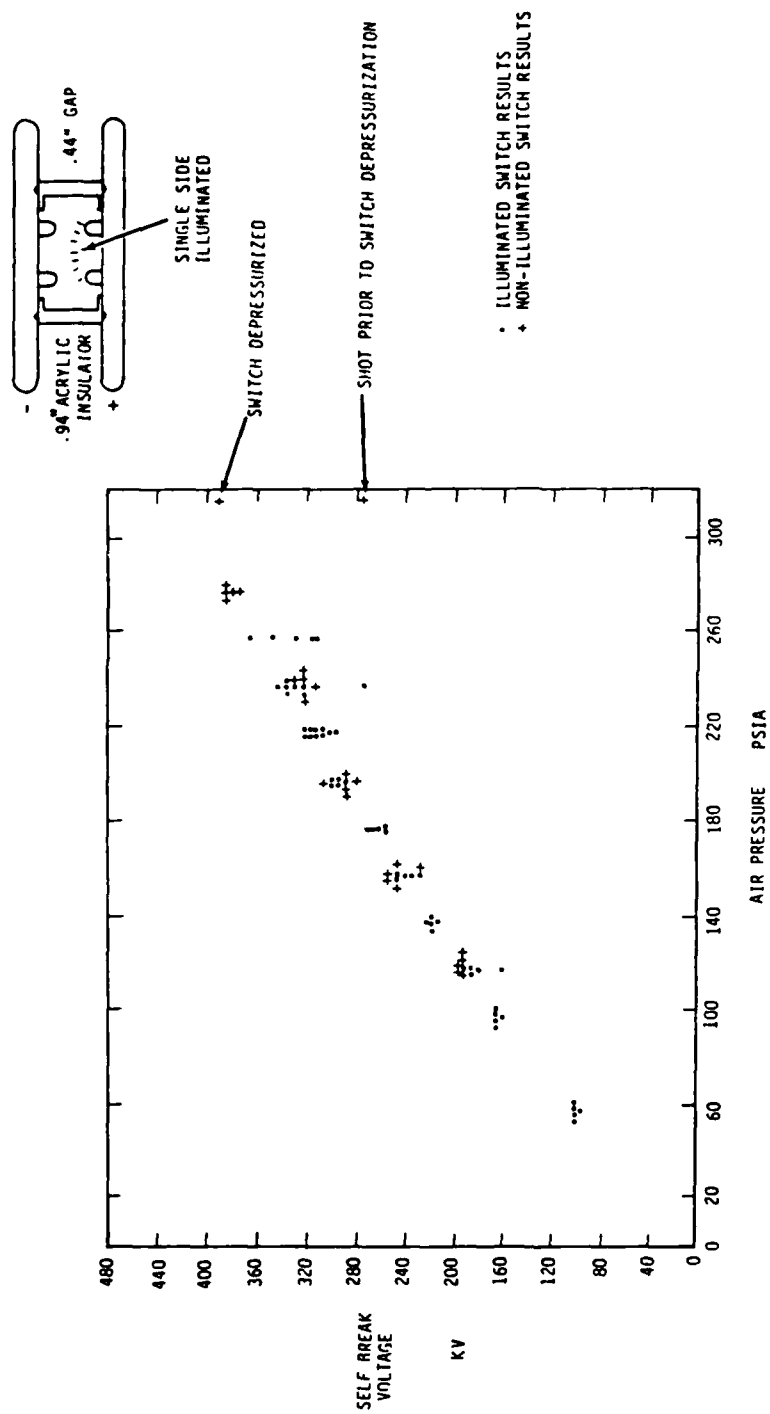
FIGURE 22 7/12/79 TESTS

The confirmation that the folded insulator was an improvement was that when it was tested, the self-break voltage for both illuminated and nonilluminated gaps was the same. This is shown in Figure 22. A comparison among various types of switches in their ratios of illuminated self-break voltage to nonilluminated self-break voltage is shown in Figure 23. This ratio should be close to one if there is no wall tracking. It should be noted that in addition to acrylic, folded insulators were tried made out of teflon (TFE), PVC and natural acetal. No difference in self-breakdown voltage was discovered among the different types.

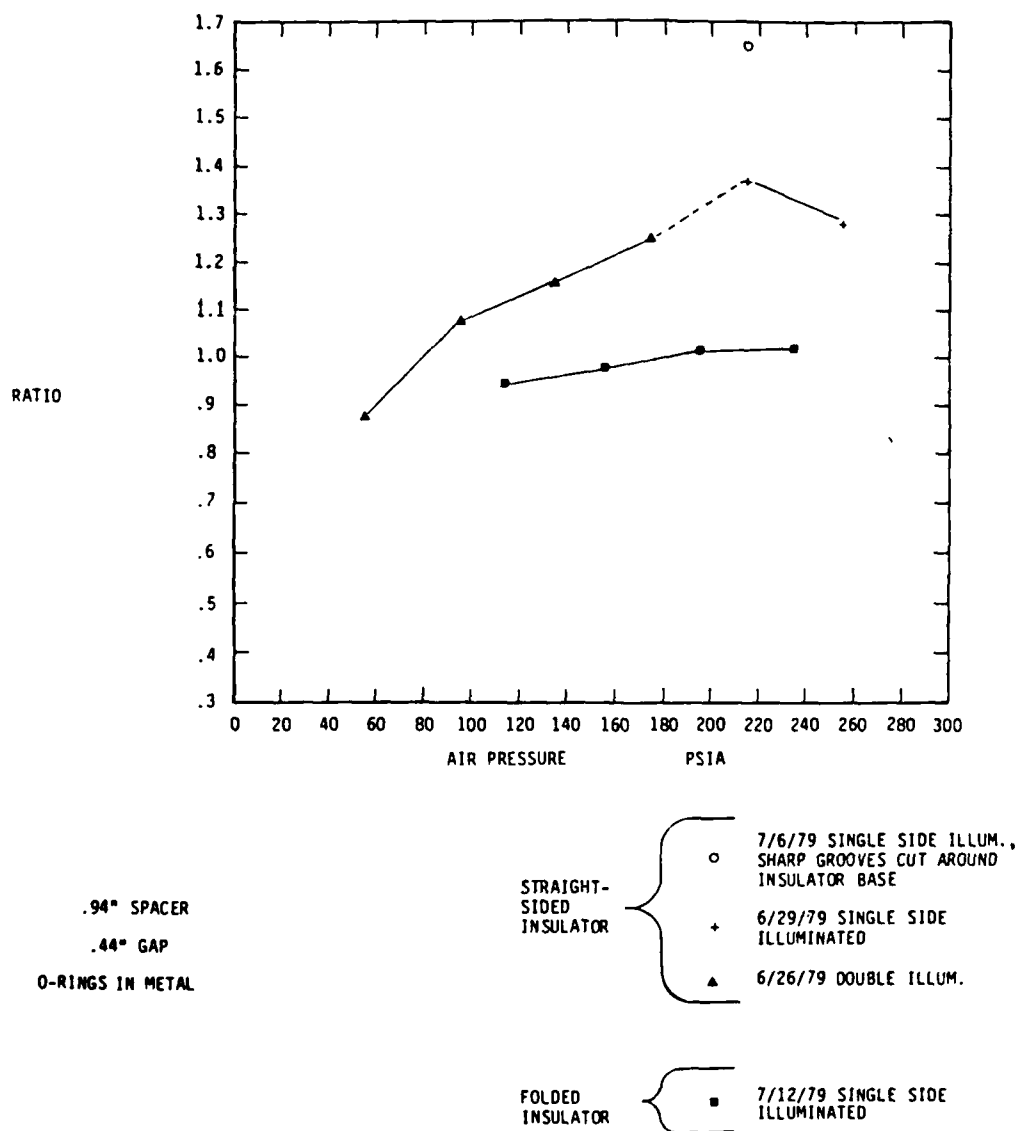
FIGURE 23 $\frac{\text{MEAN ILLUMINATED BREAKDOWN VOLTAGE}}{\text{MEAN NON-ILLUMINATED BREAKDOWN VOLTAGE}}$.COMPARISON BETWEEN INSULATOR TYPES

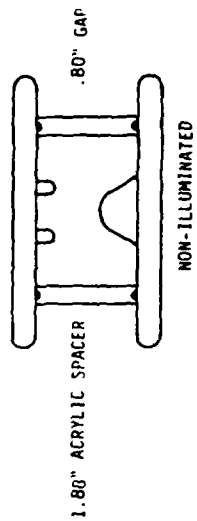
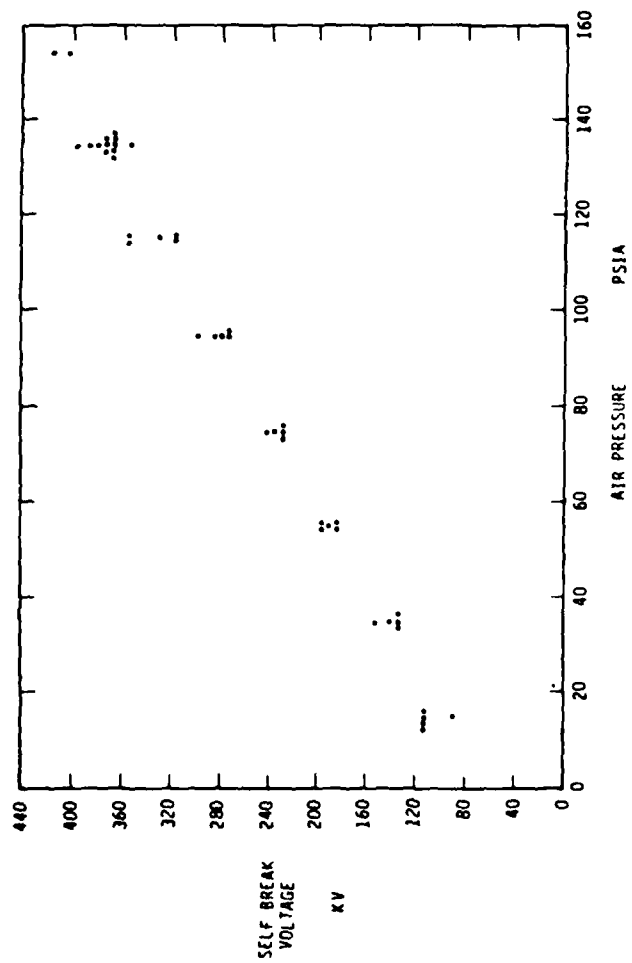
FIGURE 24 7/30/79 TESTS

NO WALL TRACKS SEEN ON INSULATOR.

One last interesting point is worth reporting. A 1978-type full-sized DQ switch insulator (O-rings in plastic, straight walls) was tried in the test stand and not illuminated. This was believed to be the approximate condition of dark switch sections at Casino. It could not be made to scatter appreciably or fail. It worked without a problem. Maximum voltage reached was 420 kV, corresponding to 4.2 MV at Casino. The self-breakdown curve is shown in Figure 24. So while these tests seemed to clearly demonstrate that the flange design gave superior wall track suppression, it is not clear why the modification was needed, if a large straight section could go to the equivalent of 4 MV. Nevertheless, because it demonstrated improved performance, the flanged insulator design was used at the subsequent Casino tests. Although several attempts have been made to return to straight-walled insulators since these tests, none have yet been successful for any number of shots.

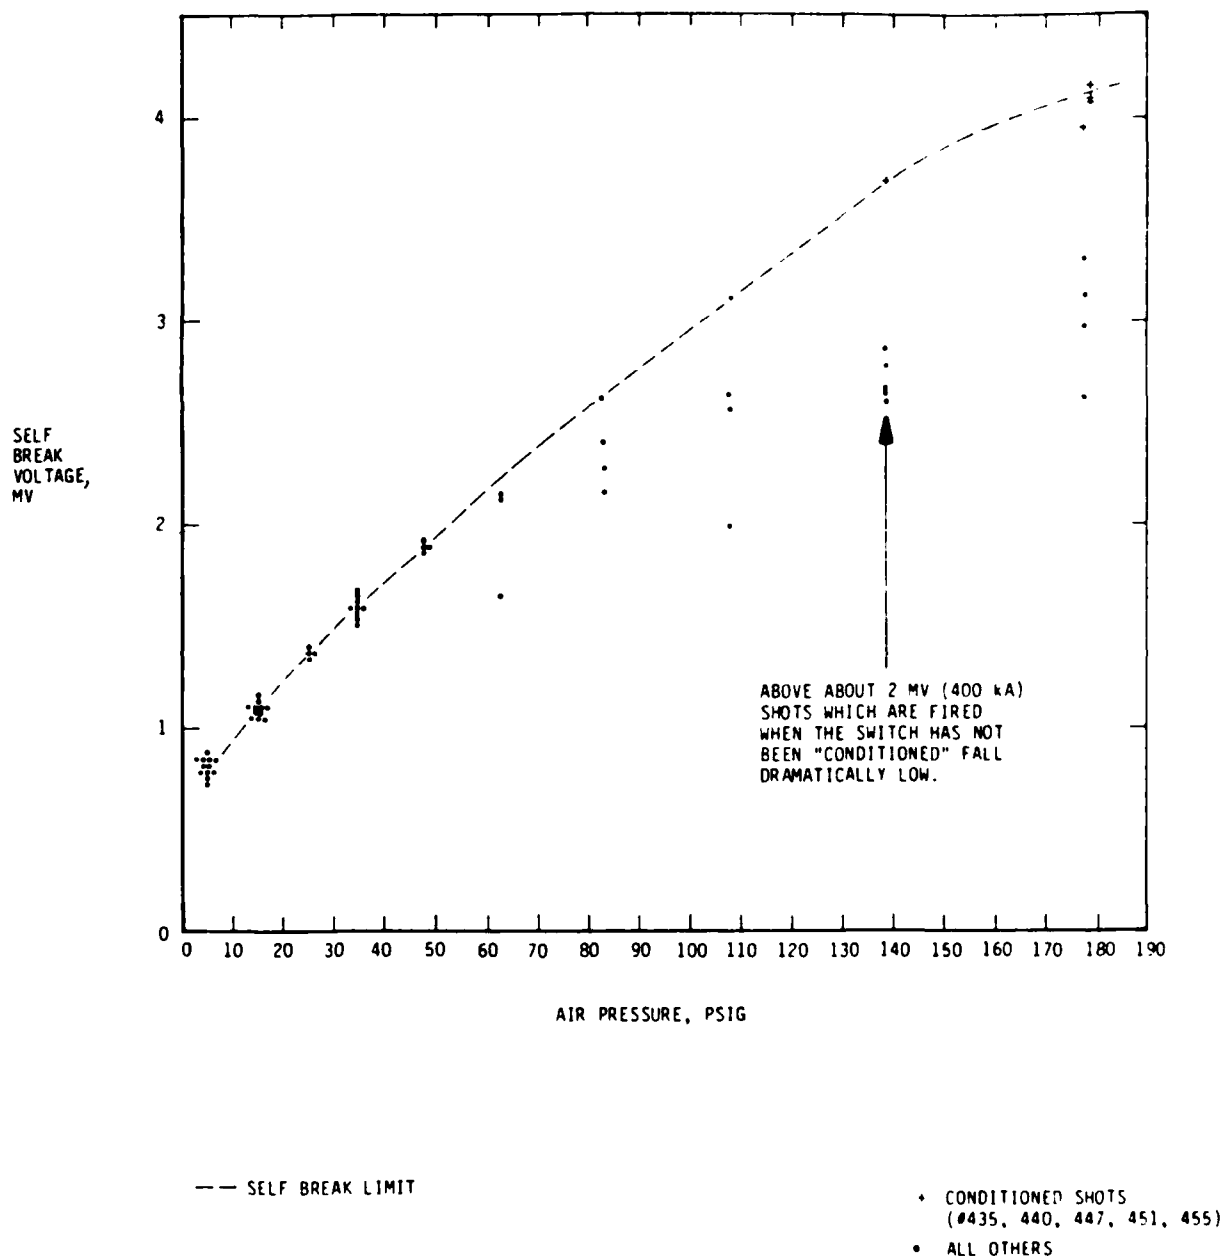
FIGURE 26 DATA FROM TABLE II (12" ELECTRODE PLATE REVERSED)

Acetal insulators were installed next. Testing started at a very low pressure (5 psig air) on the DQ switch. It was observed that the trigger section had been assembled in error. It was observed that the self-break voltage scatter of the DQ switch was very narrow (see Figure 26), up to approximately two megavolts. Above that point, it scattered (shot 408, Table I). At this time, it was discovered that the switch needed conditioning. Four 4-MV shots were obtained as a result, beginning with shot 440. The series was interrupted when the PVC blowdown tank cracked, in a mechanical failure having nothing to do with the electrical operation of the switch. Figure 26 plots the data from Table II and compares the conditioned shots with the non-conditioned ones.

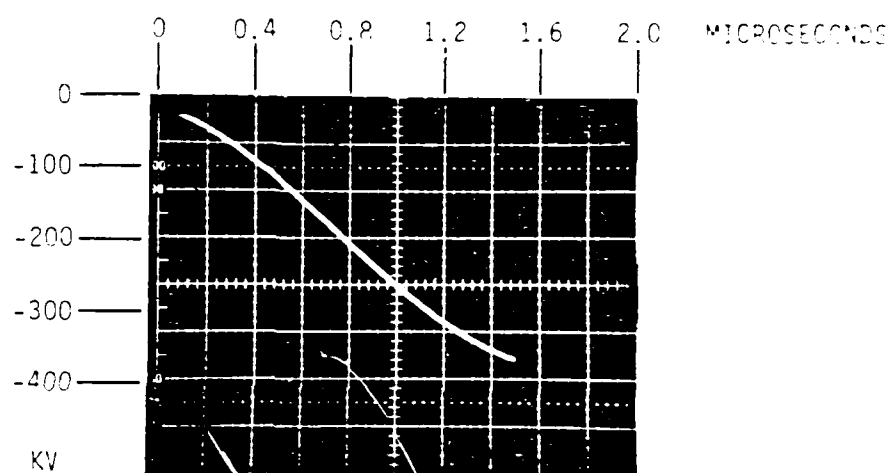
APPENDIX I
TYPICAL SINGLE SECTION SWITCH TEST WAVEFORM

FLVB2 YMIN = -4.163E+06 TIME(YMIN) = 2.220E-06
 YMAX = 2.649E+06 TIME(YMAX) = 2.484E-06

SHOT 0518 USER 0042 TIME 13:45:48 DATE 03-OCT-79

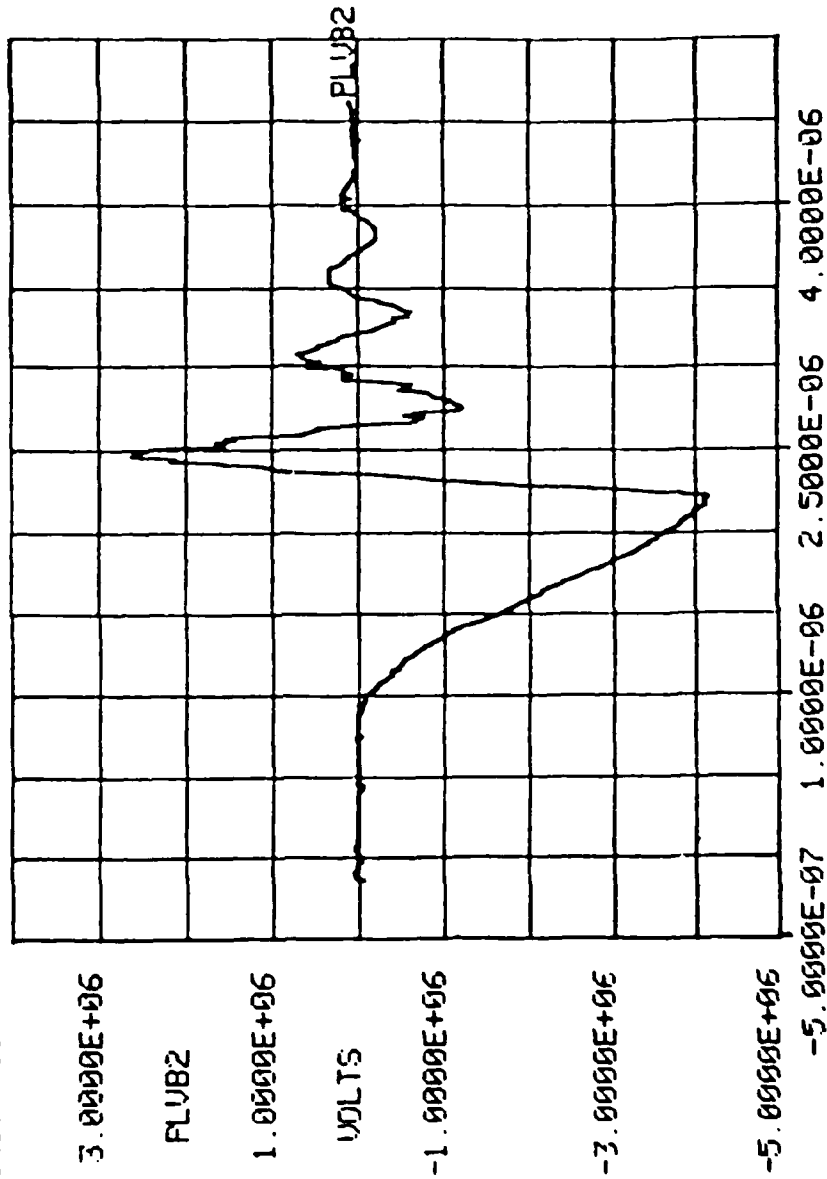
APPENDIX II

TYPICAL CASINO PULSELINE VOLTAGE WAVEFORM WITH DQ SWITCH FIRING AT 4.16 MV.
